Conserving the Roger

Bulbourne Dry Dock, Jan-Mar 2012

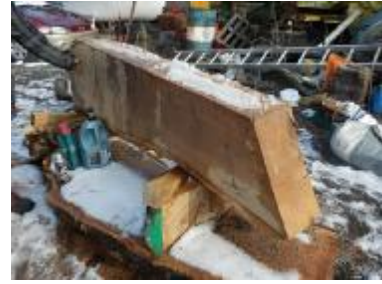
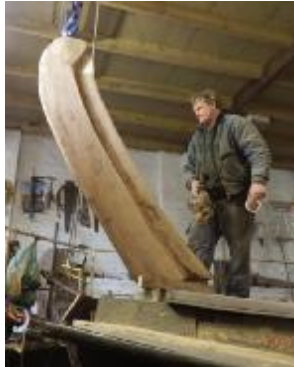
First, a new stem post – in oak. One of the key skills of the wooden boat builder is to be able to take a template from existing components, size up an oak tree, and cut the right piece out of it. Ours looked like this after the first cut: it weighed around a quarter of a tonne!

Then it was shaped, and went in like this: Steve Dearden, one of Jem's four team members, is supervising.

It then took a lot of shaping and fitting, with the bow planking itself having to be reshaped a bit to get it right. This process took well over 2 days – one of the features of conservation, as opposed to building or even restoration, is that everything new takes much longer to fit into place against the old.

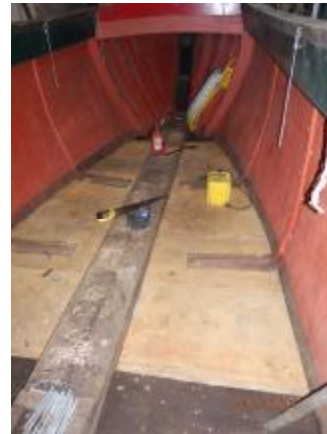
New opepe bottom planking

Jem's team then renewed the forward 14 ft of bottom planking, in opepe. The original elm just isn't available now, and opepe is often being used instead – as long as the supply holds out. It's interesting stuff – very toxic to wood boring insects, which is great, nice even grain, which is also great, but very nasty to work on, which is not so great. But it's been done – cut from templates, nailed and bolted in place, and carefully caulked. More of the caulking process later!

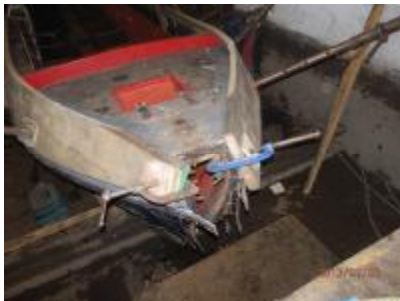
The new flashes held in position after steaming to shape

Having again taken careful templates, the tree was planked by Jem (he does all his own plank cutting) and shaped, and the new planks, 14 ft long, steamed for a couple of hours (about an hour per inch thickness). They then had to be quickly carried in and fitted to the old structure, braced from bits of dock with Acro props, and left for the weekend.

After the weekend, the new planks were taken down, and the old material, quite badly affected, cut out. The new planks, roughly in the required shape, then had to be exactly planed and cut to fit – as before, this took quite a time and a lot of effort.

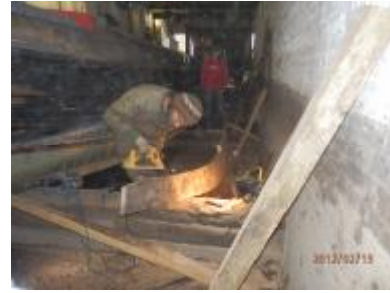
*New flashes
being prepared*

But eventually, they too were in place – bolted through the hull, and caulked in.

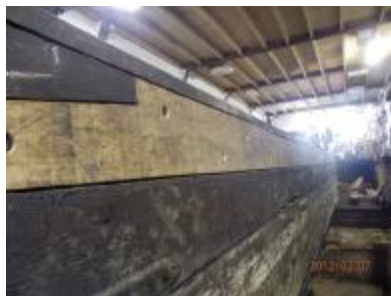
New side top plank

While this was going on, a new top plank on the starboard side had to be replaced – a length of heartwood had appeared, and begun to fail.

This was rather more straightforward, needing less shaping: but it still all had to be cut and fitted by hand, and caulked as well.

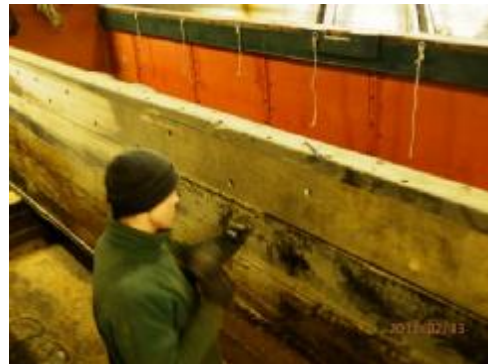
It requires the existing caulking to be either hooked out or hammered in, then the oakum to be rolled and hammered, hard, into the seams, which have to be opened up if necessary. In

the picture you can see Scott hard at it, with caulking iron and hammer: you can just see how he's twisted the oakum to form a coarse rope, pushed in ahead of the iron. He says he finds it therapeutic, but if he gets it wrong there will be a real problem later.

At the same time as all this, the hull, including the bottoms (great job, that, with 18 ins of headroom in near-zero temperatures), was being caulked. Caulking does more than just keep the water out, it's an essential part of the stability of the hull.

Once the caulking is done, the seams are sealed with marine glue, and the hull can be blacked – with hot pitch. This itself is a pretty painstaking and messy job requiring buckets of the stuff to be carried around safely – not for the fainthearted.
